Manhole Inspection Summary

Manhole # S37II_021MH

Location Address: **400 FEDERAL ST**

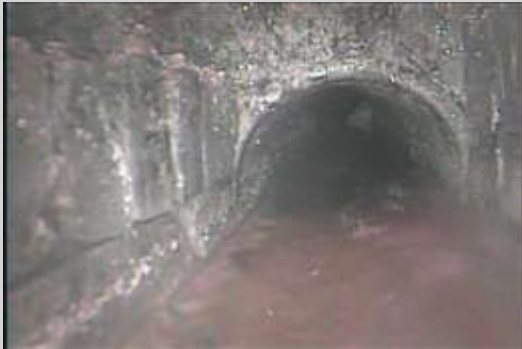
8 in. Circular Gravity Sewer Pipe Out @ 12 O'Clock

Rod and Bar (Angled)

Pipe Material: **Clay** ☐ Pipe Lined

Invert Depth: **7.89** (ft.) Flow Characteristics: **Fast**

Deposits: ☒ None ☐ Mud ☐ Sludge ☐ Debris ☐ Grease

Infiltration: **None** Pipe Seal Cond: **Unknown**

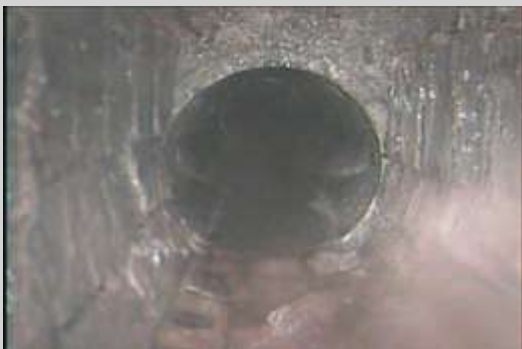
8 in. Circular Gravity Sewer Pipe In @ 7 O'Clock

Rod and Bar (Angled)

Pipe Material: **Clay** ☐ Pipe Lined

Infiltration: **None** Pipe Seal Cond: **Unknown**
